EVALUATION OF RETROREFLECTIVE AIRFIELD PAVEMENT MARKINGS

ELLSWORTH AFB,
SOUTH DAKOTA
and
TYNDALL AFB
FLORIDA

April 1995

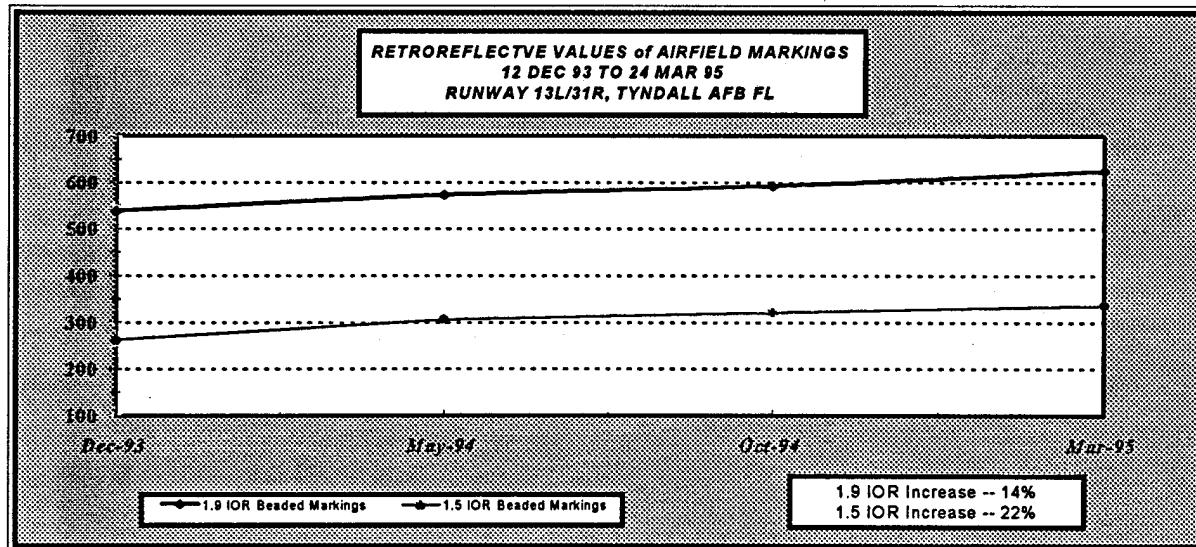
Figure 5

b. Minor damage to the inner edges (approximately two feet) of the touchdown zone and fixed distance markings occurred during a construction project to replace the slabs on the outside edge of the runway keel. The damage was caused either by the slurry spill-over common during the pouring process, or from the curing compound used. The damage occurred during the closure from 1 May 94 to 31 Jul 94. This condition was noted while performing a visual inspection prior to taking the retroreflective readings on 27 Oct 94. To prevent this condition from impacting the test, the damaged areas were avoided by relocating the instrument approximately four feet inboard form the inner edge of the markings while taking readings.
